ROOFING, FLASHINGS AND CHIMNEYS

ELECTRICAL

HEATING

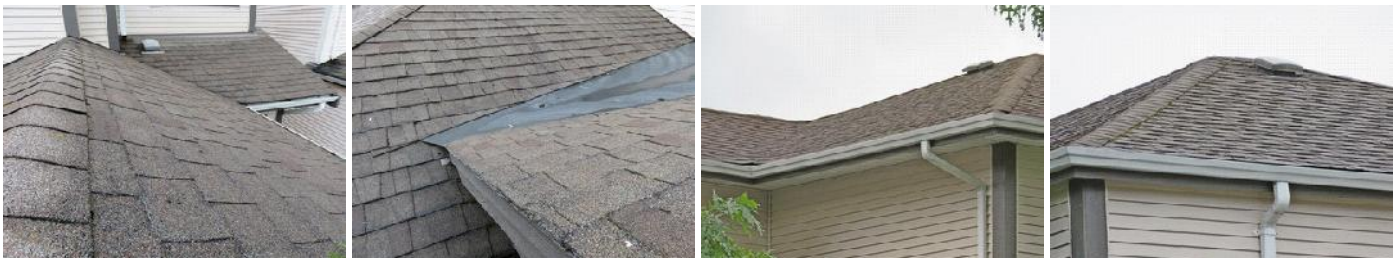
Slope Roof Covering

• Moss and/or debris accumulated on the roof at the time of the inspection may damage roof covering materials by retaining moisture. Clearing the roof of debris should be included in annual maintenance.

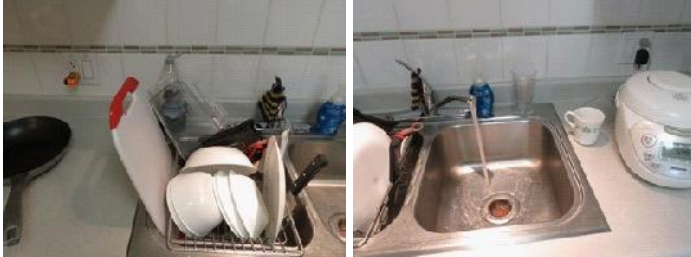
Outlets

• Electrical outlets in the kitchen were operable at the time of the inspection but had no Ground Fault Circuit Interrupter (GFCI) protection. Consider having GFCI protection installed for outlets within 6 feet of plumbing fixtures. All electrical work should be performed by a qualified electrical contractor.

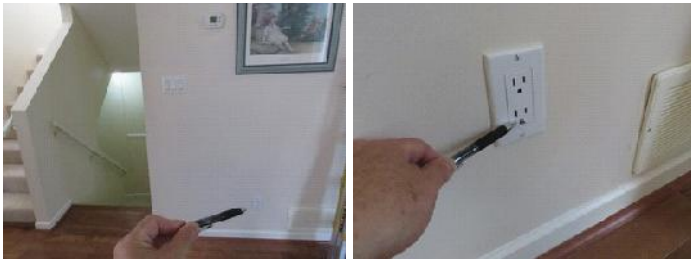
Undergrounded Outlets – 3-prong, fill ground slot, GFCI

• An electrical outlet in the living room with a plugged ground hole and should be replaced by a qualified electrical contractor.

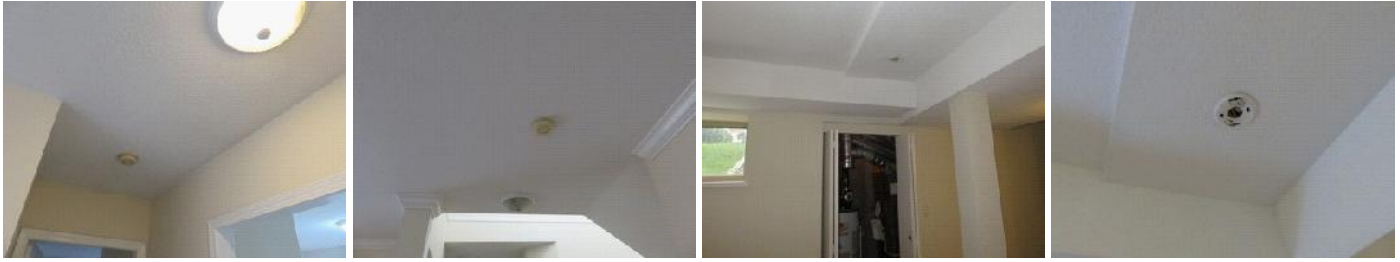
Smoke Detectors/ Carbon Monoxide Detectors

• Smoke detectors in the upstairs and main floor that appears older than 10 years. The smoke detectors should be replaced as it is recommended that smoke detectors should be replaced every ten years with new ones.

- Smoke detector was missing in the basement near stairway. The Inspector recommends that smoke detector be installed in compliance with modern requirements.
- No Carbon Monoxide detectors were provided in the home. The Inspector recommends installation of Carbon Monoxide detectors in appropriate locations.

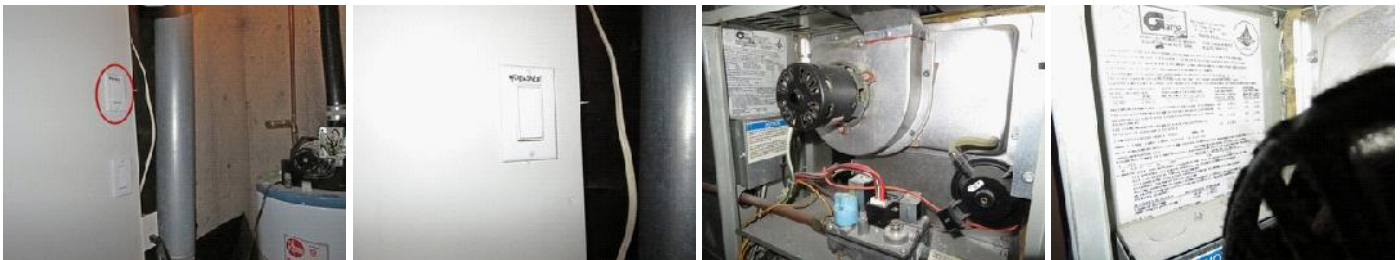
Furnace

• The furnace electrical shut-off is shown in the photo. The emergency shut off switch is to shut off the furnace of the home in case of a gas leak or fire.

• The furnace was dirty and lack of maintenance. The Inspector recommends that furnace cleaning, service and certification be performed by a qualified contractor regularly, with measurements according to the data plate.

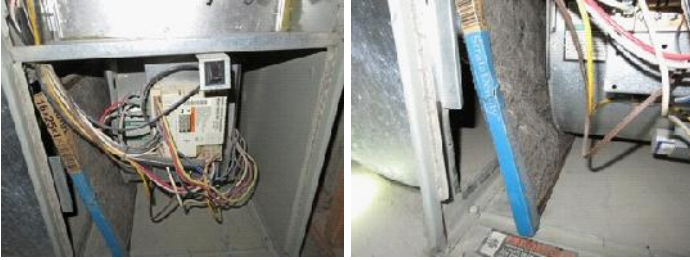
Air Filter/ Electronic Filter

• The furnace air filter was located in the lower blower compartment. Access was through the furnace front. Shut off the furnace at the electrical switch before attempting any service such as filter replacement. After removing the upper panel, lift up and pull off the cover of the lower compartment. The air filter should be checked quarterly and replaced when dirty.

- The furnace air filter was dirty and should be changed on the date of inspection.

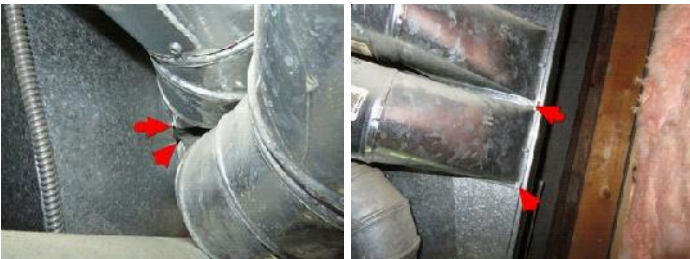
Supply/ Return Ducts & Registers

• Check heating ducts for loose connections or cracks between joints and seal. Foil tapes can be used to seal around the seams of heating ductwork to reduce air leakage. When sealing ductwork, seal both the cold air return and hot air supply.

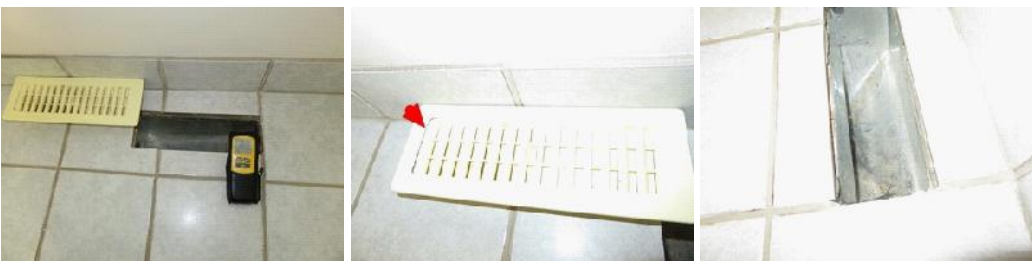
- Heating supply register cover in eating area was cracked and should be replaced.
- Heating ducts are dirty at the time of the inspection; Duct cleaning throughout by specialist is required.
