PLUMBING REPORT

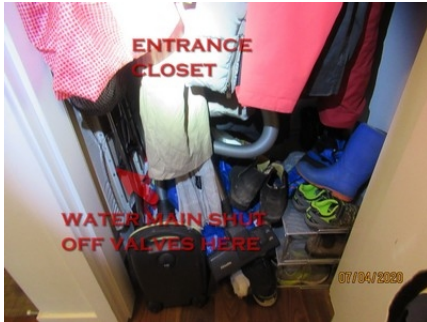
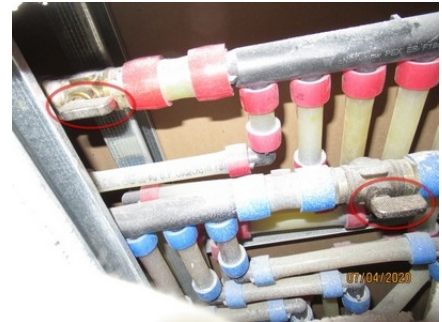
Main Water Shut off Valve

The main water supply shut-off valves were located in the entrance closet. Although the main water supply shut-off valves were not operated at the time of the inspection they were visually inspected and appeared to be in serviceable condition.

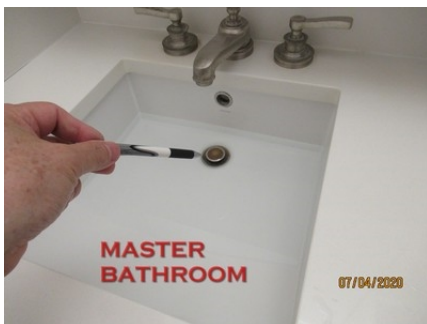
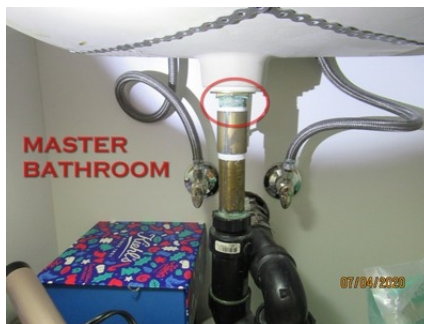
Sinks & Faucets

Slow draining sink at master bathroom. Impaired intended function. Improvements required.

Sink drain pipe connection was leaking in master bathroom. Leak risk. Improvement or repairs required.

Improvement and Repair Recommended
